SOLAR SECURITY FILMS, INC.

CAP JULUCA ENERGY REDUCTION STUDY

Caribbean Energy Savers

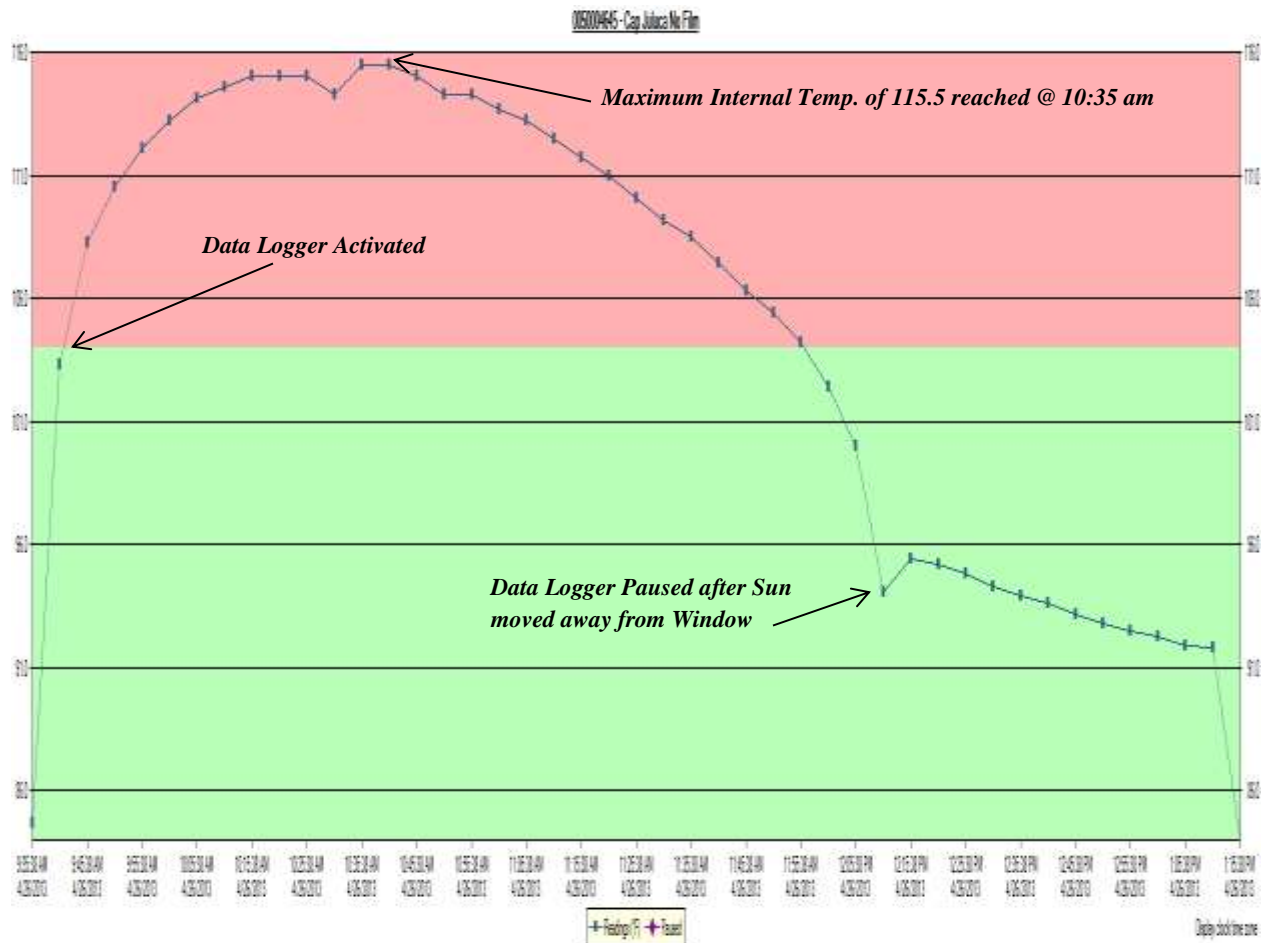
MICRO DAQ Log Tag Temperature Data Logger was programed and set up in the bathroom to record internal temperature readings at five minute intervals. The device was activated at 9:35am and recorded a maximum internal temperature of 115.5 degrees in front of the window. This excessive heat condition is no match for the cooling system and causes the air conditioning to continuously run in an effort to overcome the heat load. The detailed time stamped study is attached to the report for your review.

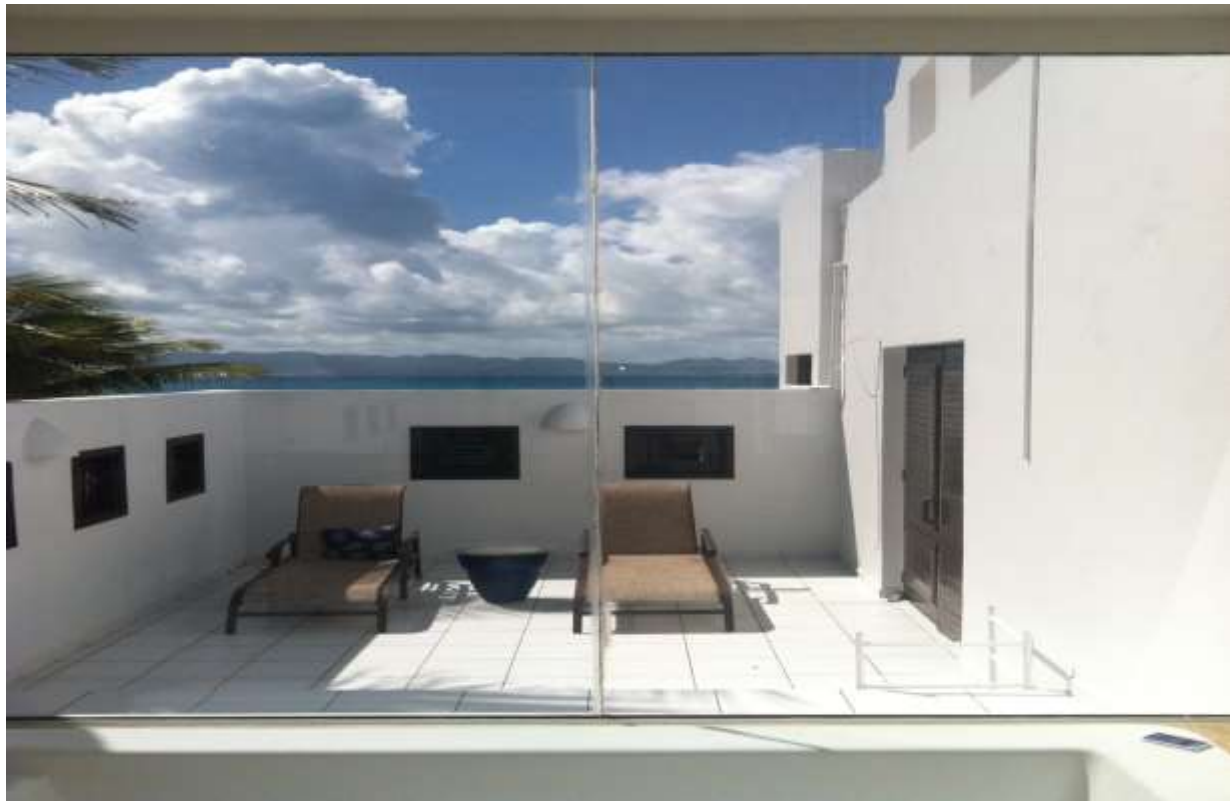
After the sun had moved away from the window, 3M Prestige Series PR50 “Clear Heat Control” Window Film was installed onto the window glass and the Log Tag Temperature Data Logger was re-programmed to take readings for the following morning. The above referenced photograph is actual picture of 3M PR50 installed onto the bathroom window wall of Villa 15. Below is the graphical analysis showing a 20.1 degree temperature reduction post PR50 installation.

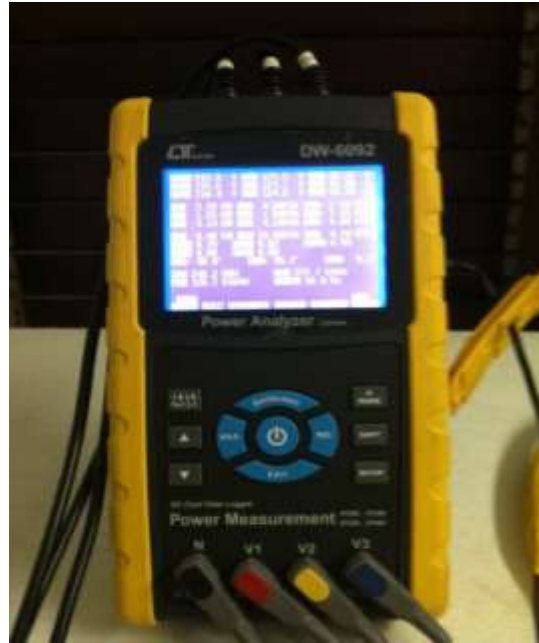
LUTRON DW-6092 Three (3) Phase Power Meter Analyzer with Real time Data logger was tied into the main breaker panel located at Villa 15. The energy monitor was programmed to take real time energy consumption readings in 30 second intervals for a full 24 hour period to develop a baseline of daily energy consumption. All four (4) air conditioners were set at 70 degrees by [REDACTED] Cap Juluca Maintenance Technician, as directed by [REDACTED]
